Stainless Flexible Service Line

Simply Fit and Forget!

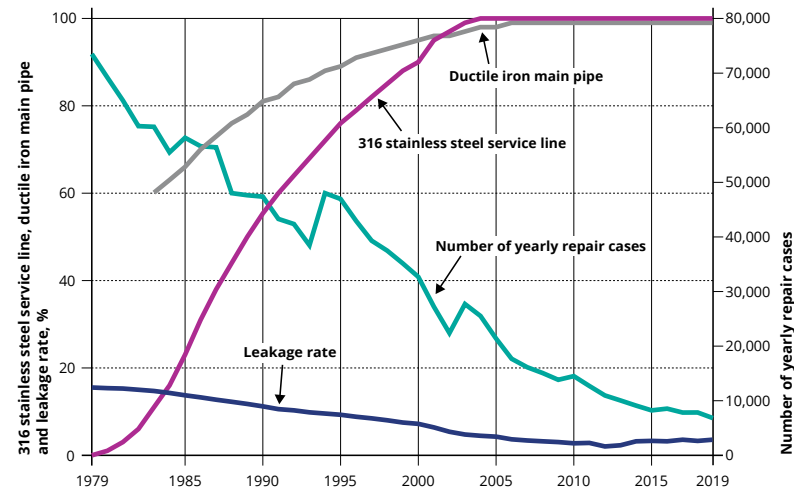
Gains made by using stainless steel in Tokyo.
Source: Tokyo Bureau of Water Works

Tokyo's replacement program resulted in a water loss reduction from 260 million m³ (15.4 %) in 1980 to 56 million m³ (3.6 %) in 2019. At the same time, repair cases were reduced from 69,000 per year to 7,000 per year. The total savings amount to almost 500 million USD per year.

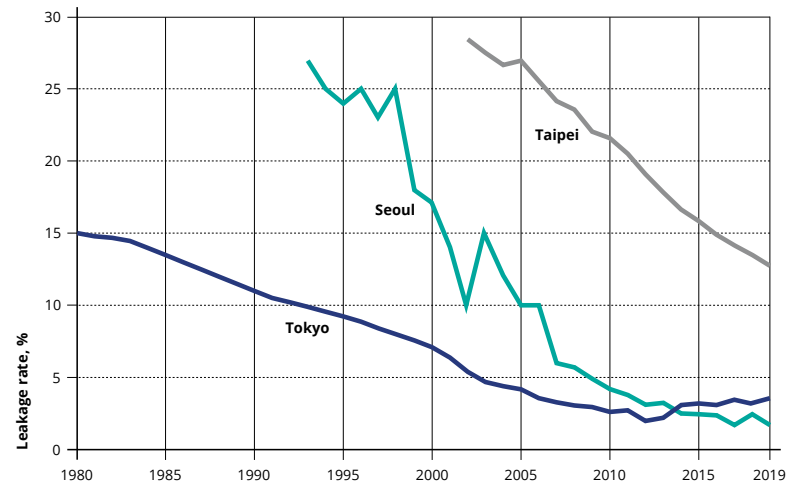
Leakage reduction in Asian cities through use of stainless steel service lines.

Tokyo's success at reducing leakage attracted the attention of Taipei and Seoul. Following a drought causing severe water shortages, Taipei began evaluating their program in 2002 and started their 20-year stainless flexible service line installation program in 2005. This resulted in a water loss reduction from 365 million m³ (27 %) in 2005 to 109 million m³ (12.7 %) in 2019, in just 12 years. At the same time, repair cases were reduced from 11,300 per year to 2,600 per year in 2019. When even more severe drought conditions returned in 2014, Taipei had no service disruption. In fact, it was able to maintain a surplus which was distributed to storage reservoirs and other utilities.

In Seoul, following the installation of stainless steel service lines, water leaks reduced from 27 % to 2.5 %. It has also enabled the city to reduce its total water production from 7.3 million m³ to 4.5 million m³ per day, leading to the closure of four of the original ten water treatment plants.
