Good Safety Practice in Stainless Steel

Introduction

Good Practice Case Studies

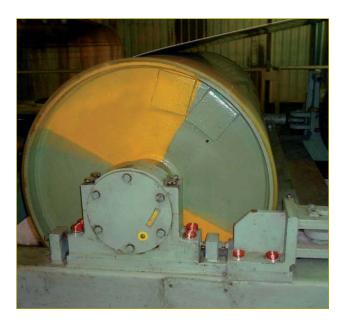
Images show the new cleaning device on the roller.

An automatic cleaning device was added to the rollers the day after the accident to minimise the need for manual cleaning of the rollers. The cleaning device has also been added to all of the bridle rollers on the line.

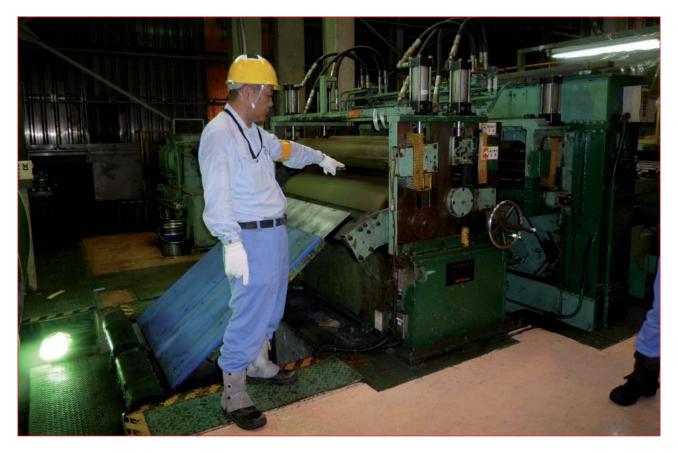
A pendant switch was installed. This is worn around the operator's neck and enables him to open the rolls, thereby reversing the direction in which the rolls turn. An interlock switch with indicator light was fitted to the machine, enabling the operator to easily tell when the rolls are in the correct cleaning position.

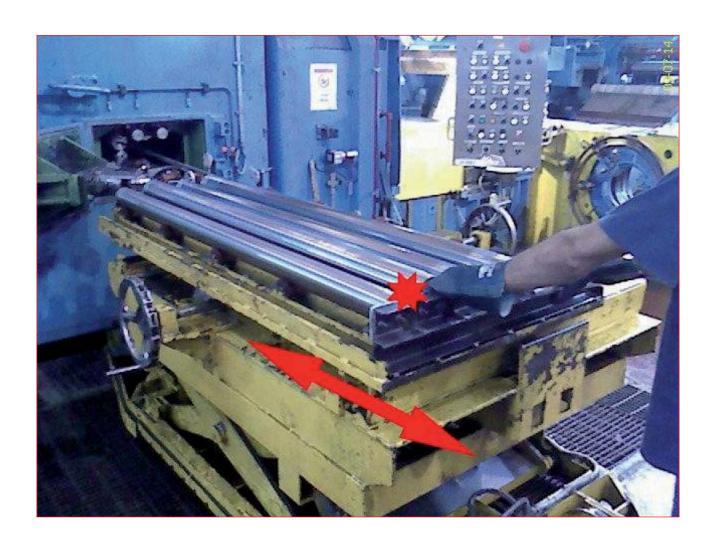
A handle was installed on the operator's side of the cart so that it could be held more securely. Safety meetings were also held to improve the attention level of the operators.

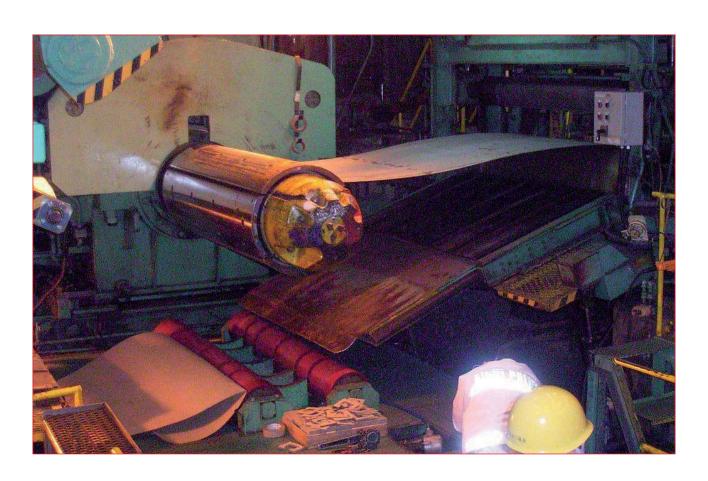
The existing work procedure was revised. An interlock was installed on the line and linked to an indicator light. If the cylinder breaks the interlock is activated and prevents the cylinder from moving. The cylinder was replaced with one made of stronger material and with a larger diameter.

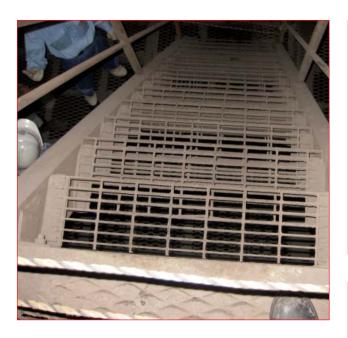
A flat bar was attached to the lip of each step so that the edge of the stair is at a different level to the tread. A winch and shooter were also installed so that the dust did not need to be carried down the stair. Checks by supervisors are now carried out when spot work is done.

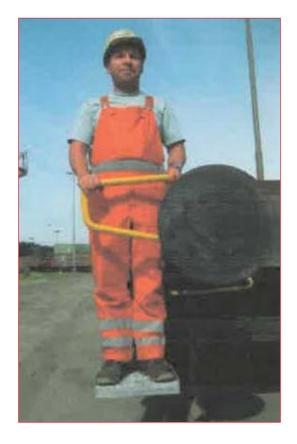
The treads of the steps on the train were enlarged and the hand-holds improved significantly. The images show the steps and hand-holds before and after they were improved.

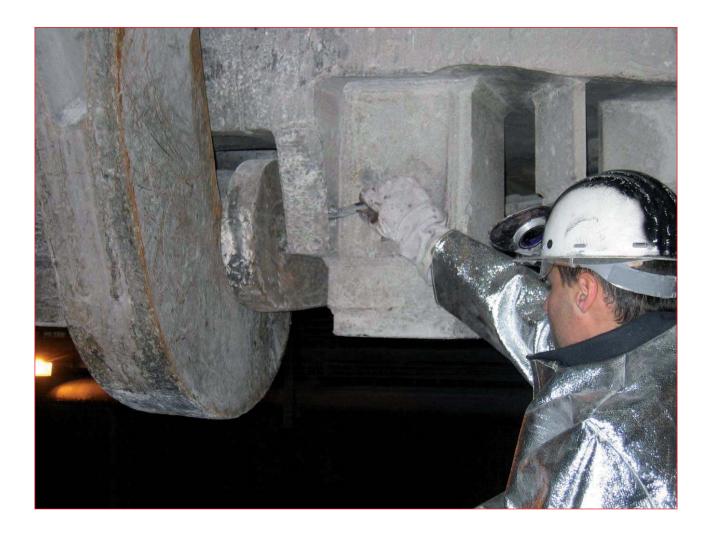
As it is difficult to manufacture a pin that will not wear over time, a spacer was placed into the metal pin. This enables the operator to lock or unlock the device without their hand coming into contact with the metal structure.

The new metal pin with spacer was installed.

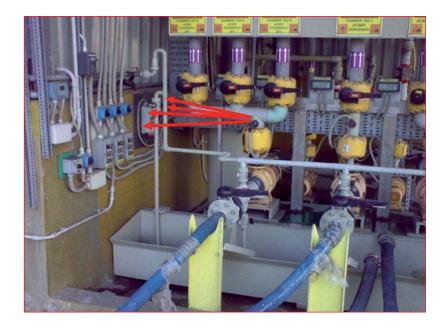
A discharge valve system was installed in every flow-meter pipe, enabling them to be completely depressurised.
