Breakwater repair

Bayonne, France

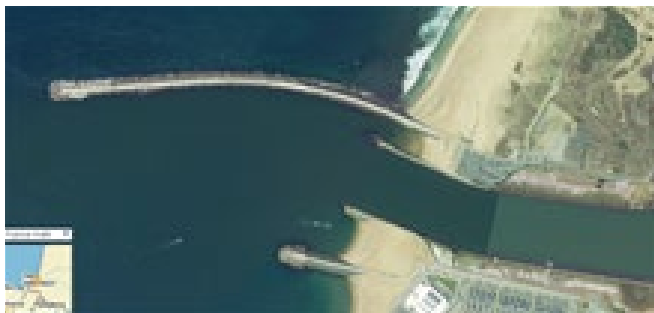
Aerial view

Being located at the Atlantic coast of France, the harbour of Bayonne is regularly exposed to stormy weather. In the 1960s, a breakwater was erected to protect the entrance channel. It included a wall and also a platform wide enough to accommodate a heavy duty crane used to place and re-position the 40t concrete blocks that cover the exposed outside of the structure.
